**REPORT  
OF  
COMMITTEE OF INQUIRY**

**ACCIDENT TO PILATUS PC-12 AIRCRAFT VT-ACF OF  
M/S AIR CHARTERS SERVICES PVT. LTD. AT FARIDABAD HARYANA  
ON 25.05.11**

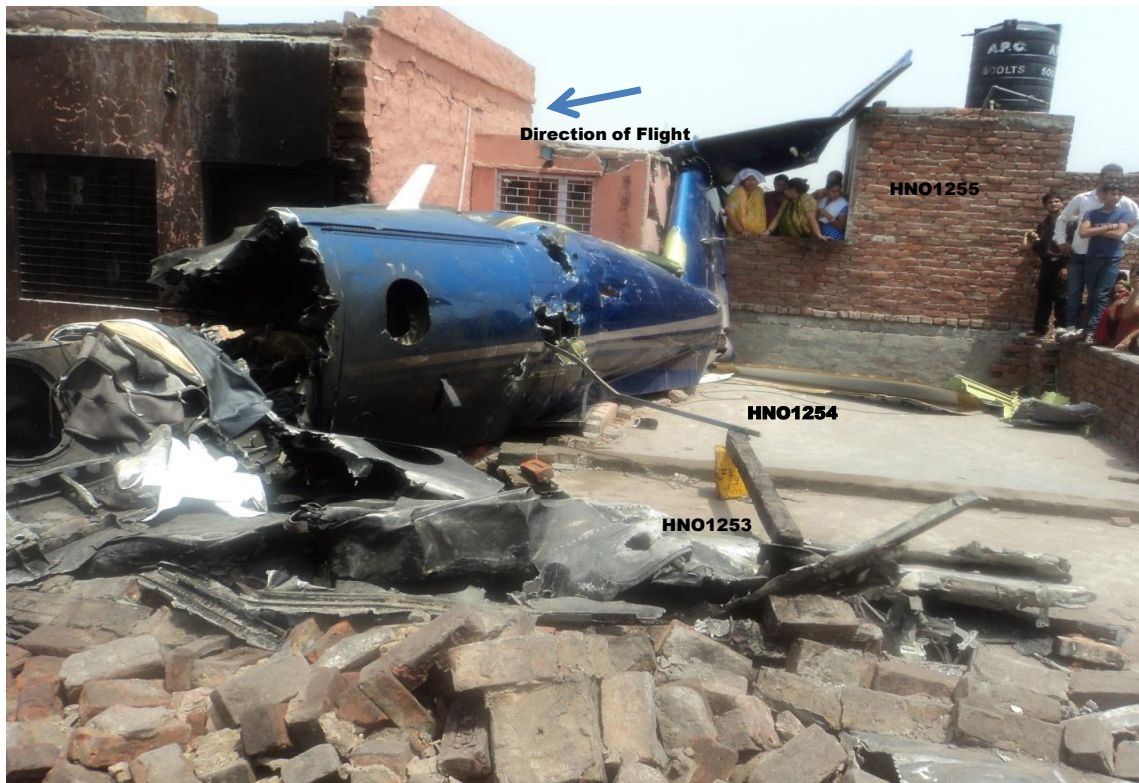
***Wreckage In Final Resting Position***

Accident site is a densely populated residential area in district Faridabad, Haryana. The coordinates of the accident site are N 28° 21'37.08", E 077° 16'58.2". Due to impact the aircraft had broken into a number of pieces. **There was no significant spread of the wreckage**. The wreckage was mainly concentrated on House No. 1254 and House No. 1253. The aircraft approached the accident site in right bank with negative pitch attitude.

The forward motion of the aircraft was restricted as the right side of the fuselage, engine and the right wing impacted the boundary wall on the roof of the house no 1253. The main wreckage was lying on the roof top of the House No. 1254. Due to the impact of the right wing the forward facing wall of a room on the roof of the House No 1254 (between House No. 1253 and 1254) was shattered.

The remaining portion of the structure of the House No 1254 received fire damage and was covered with the smoke possibly due to bursting of the fuel tank in the right wing. Roof of House No. 1254 made of concrete collapsed at few places due to impact. All the three landing gears of the aircraft were hanging down through the collapsed roof. A large portion of the right wing was recovered from the floor level in the House No. 1254. Due to impact and fire the aircraft was destroyed. No aircraft part was recovered before the final resting place of the wreckage. No ground marks, fire/soot marks were observed before the final resting place of the wreckage.

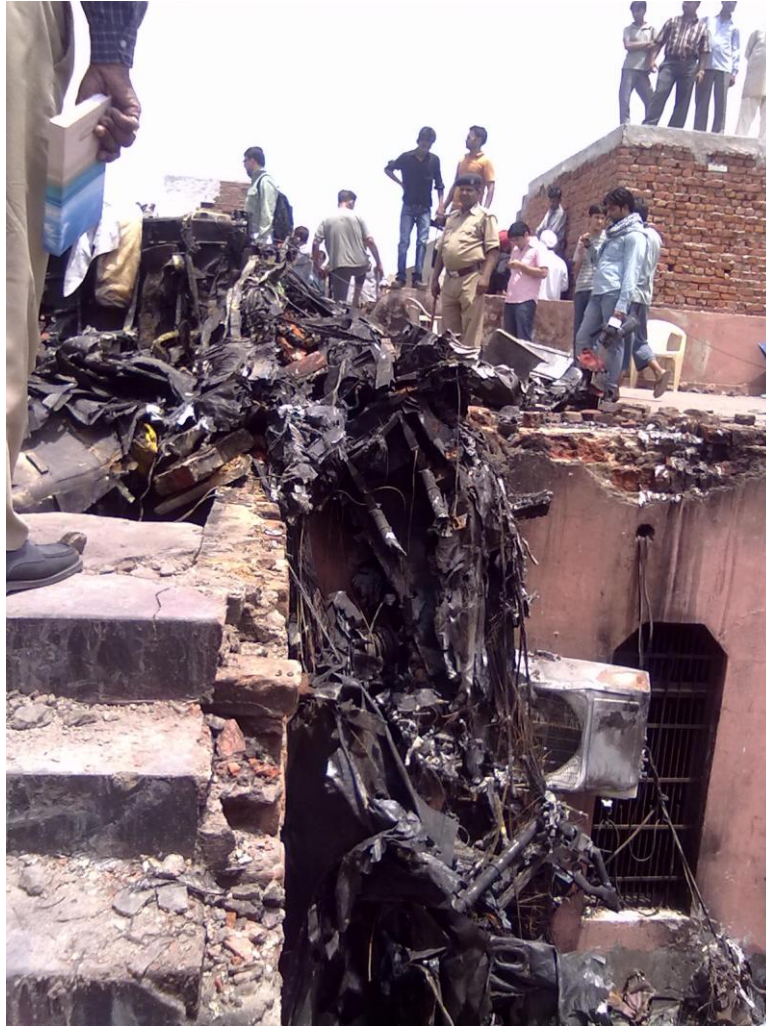
- (a) **Cockpit:** After the impact, nose and cockpit section caught fire and was fully consumed in it. The burnt remains of the cockpit along with cable and linkages were hanging from the roof of house No. 1253.

Few of the cockpit instruments, avionics equipments were recovered in burnt condition and a portion of fully burnt crew seat was found in the centre section of the fuselage.

**Front View: Forward Portion of Fuselage hanging from the roof of  
H. No. 1253**

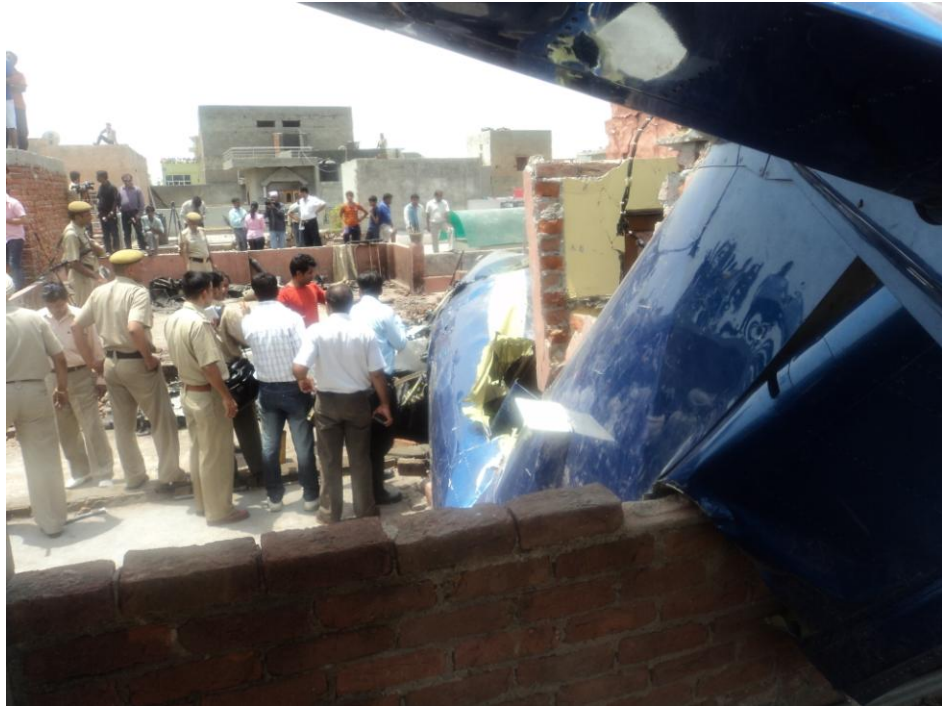
Vertical stabilizer was attached at its position. Impact damage was seen all along the leading edge. At the joining of vertical stabilizer with the leading edge of horizontal stabilizer, skin tear was observed. The rudder was attached with the vertical stabilizer and bent towards right. Portion of dorsal fin and vertical stabilizer with portion of rudder attached but bent towards right. Horizontal stabilizer was found in position and elevator was attached to it. A portion of rudder and elevator found broken after hitting a building. Left horizontal stabilizer along with elevator had impacted top of masonry structure and finally resting on it. Due to impact it had bent upward. Horizontal stabilizer actuator intact in own position but bullet fairing was damaged. Control Linkages for rudder and elevator found intact with cables attached. Elevator was found in level condition. One lead acid battery was found in good condition but the other battery was fully damaged.

**Rear View: Indicating damage to the Rudder**

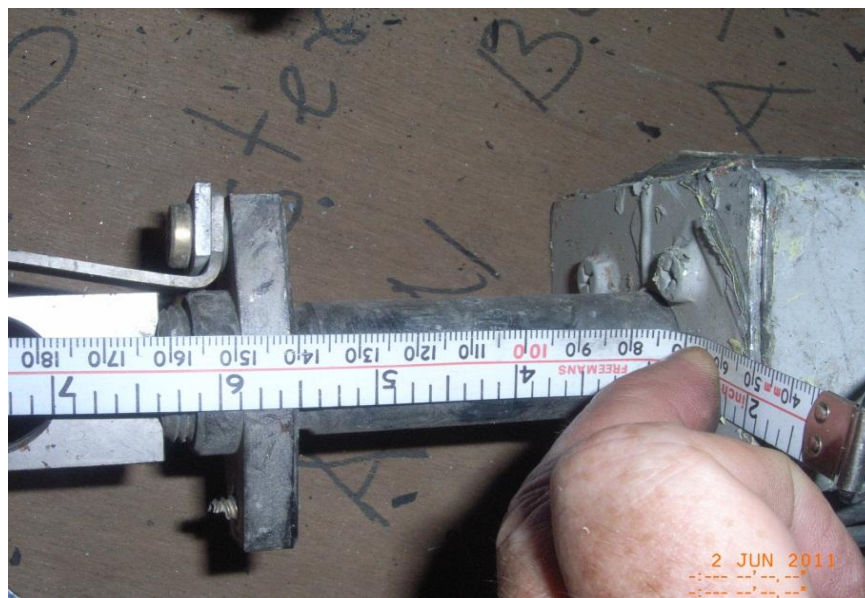
###### (a) Pitch Trim Actuator

The pitch trim actuator was found extended by 70 mm. A preliminary analysis determined this position as being within the green take-off range.

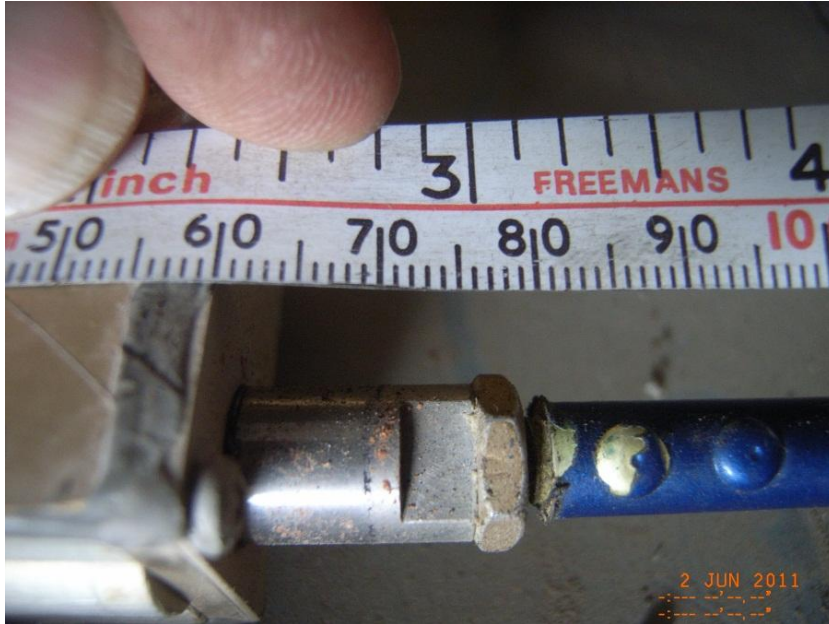
**(b) Aileron Trim Actuator**

The aileron trim actuator was found to be extended 16 mm to the bottom of the nut. This equates to approx. neutral trim.

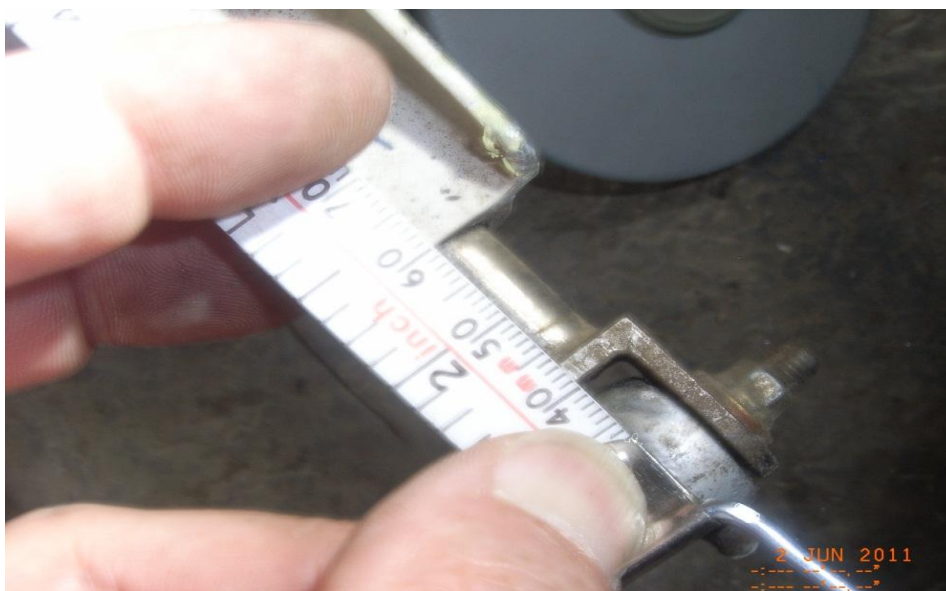
**(c) Rudder Trim Actuator**

The rudder trim actuating rod was found extended by 17 mm when measured against the support strut. A preliminary assessment indicates that this equates to some aircraft nose right trim.

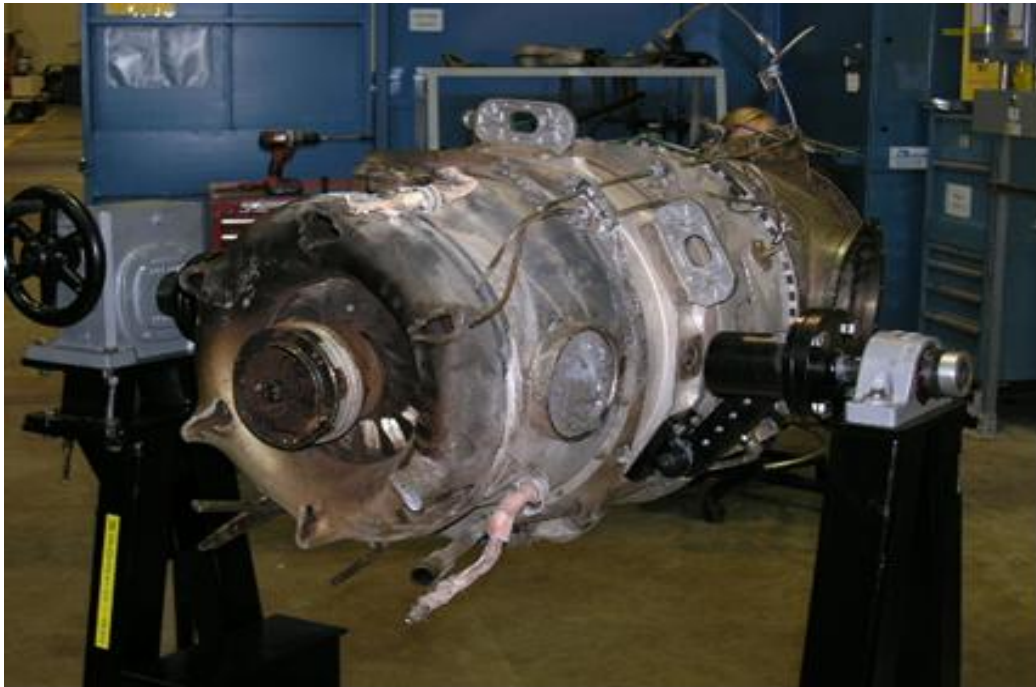
**Engine right hand aft view.**

The engine displayed severe impact damage including complete structural separation of the reduction gearbox forward housing and the accessory gearbox

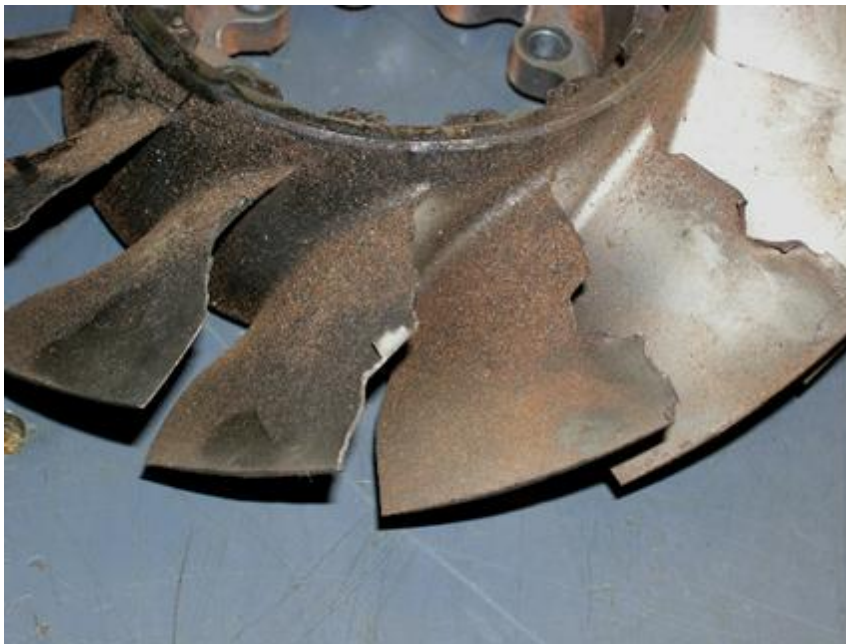
Engine displayed deformation to the compressor 1<sup>st</sup> stage blades

**Compressor 1<sup>st</sup> stage blades, detail**

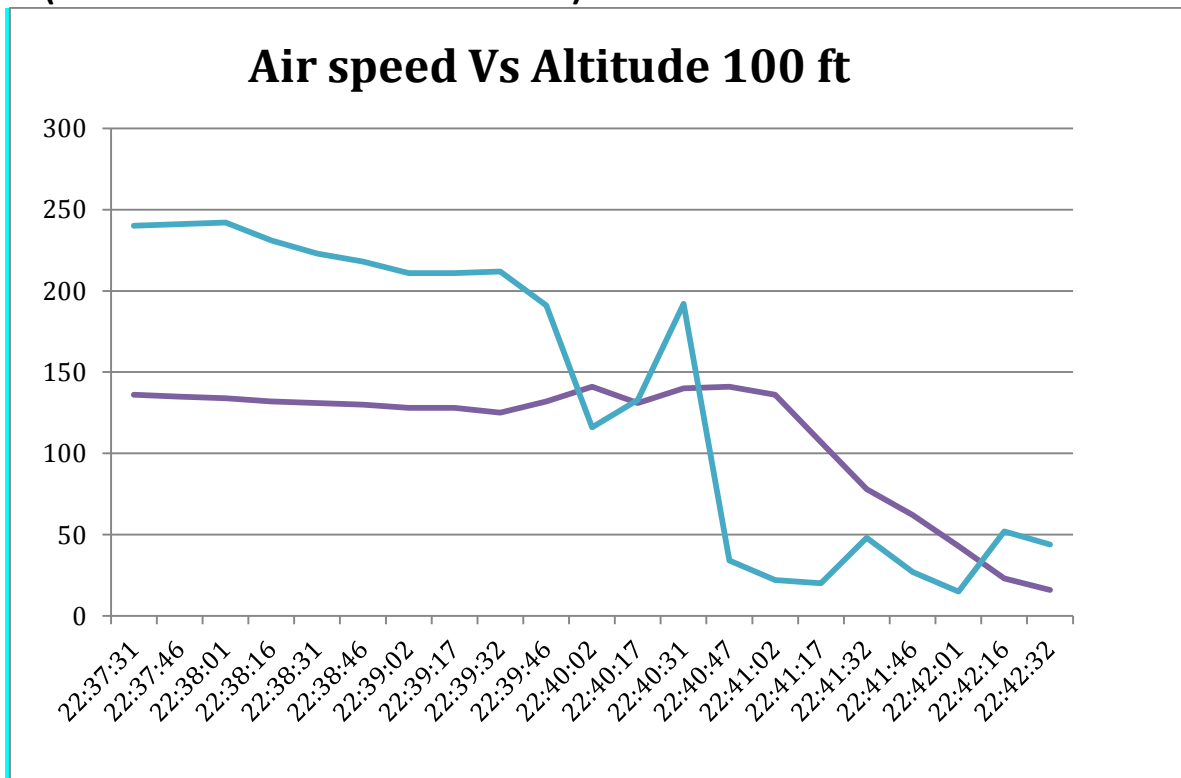
**Fig6. Air Speed and Altitude vs Time**

3.1.1.4 It appears that the aircraft had rapidly gained height from 12,500 ft. to 14,100 ft. (Refer Fig6.) at 22:39:32 IST with a substantial ROC coupled with a marked reduction of Ground Speed. The aircraft has thereafter descended just as rapidly by 1000 ft. to 13,100 ft (Refer Fig6.) by 22:40:17 IST, indicating the aircraft had encountered an up draft followed by a down draft. The aircraft again appears to have hit another updraft at this juncture and has rapidly climbed once again to 14,600 ft (Refer Fig6.) at 22:40:37 along with a rapid drop in speed and in an abrupt climbing turn to the left. This rapid climb coupled with the excessive drop in speed appears to have caused the aircraft to have departed controlled flight at 22:40:37 IST.
